Farmers' and Mechanics' Bank
427 Chestnut Street
Philadelphia
Philadelphia County
Pennsylvania

HABS No. PA-1415

ARCHITECTURAL DATA FORM

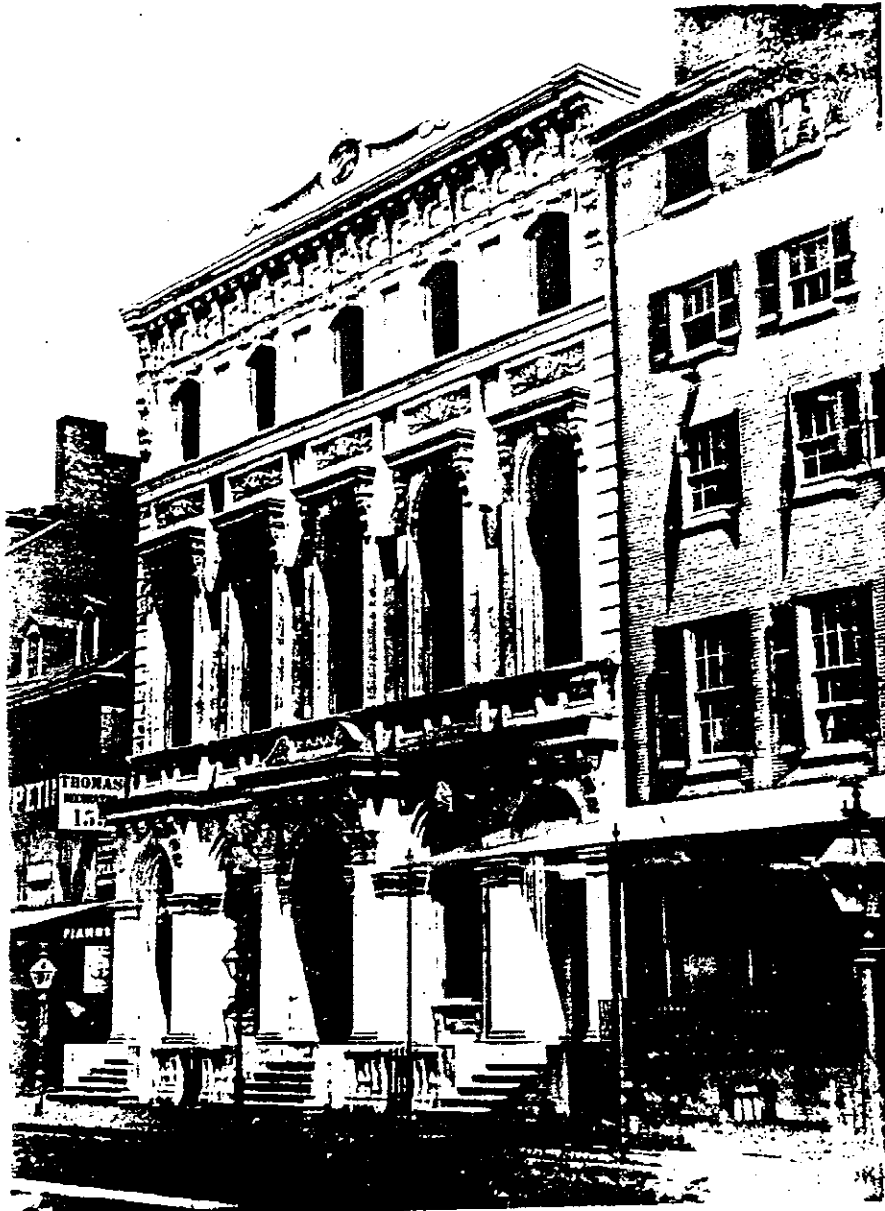
19th century photograph of the building

Courtesy of City Hall, Philadelphia, Pa.
Photo No. 25, Vol. 7, Philadelphia Miscellaneous Views.
Photographic Unit, City Hall.
